#### **Case Study: Tank Farm Relocation from West Yorkshire to South Wales**

To dismantle the gantry between the 8 vessels and re-engineer to fit the proposed location in South Wales. Remove the 8 cladded bulk storage vessels from the bund and transport to South Wales as abnormal loads. Once on site rebuild the gantry and secure to the floor. Position the eight vessels in their new places.

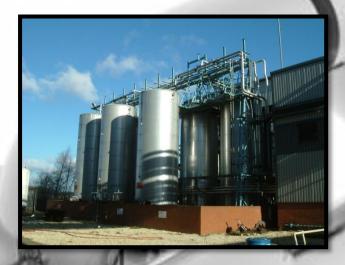
The tank farm pictured before work started. As you can see there are only 7 vessels here, the other one was located close by on the same site.

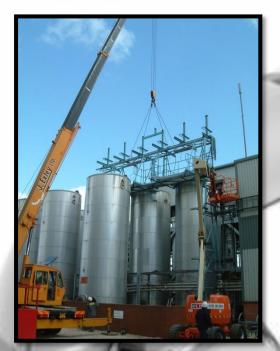
Lifting the second half of the walkway down so it can be transported elsewhere on site for re-engineering.

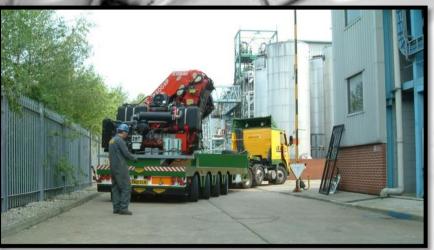
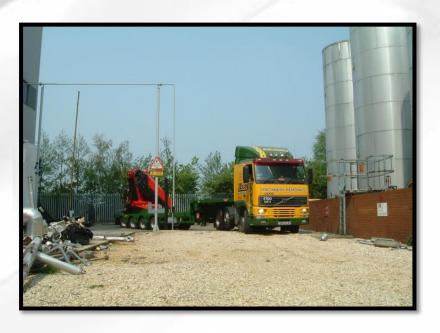
Left and below: Moving the heavy lifting equipment into position ready to start lifting the vessels out.

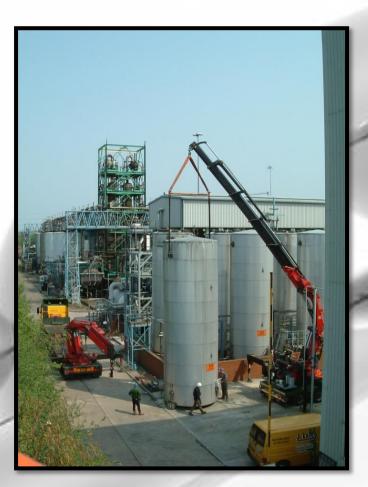
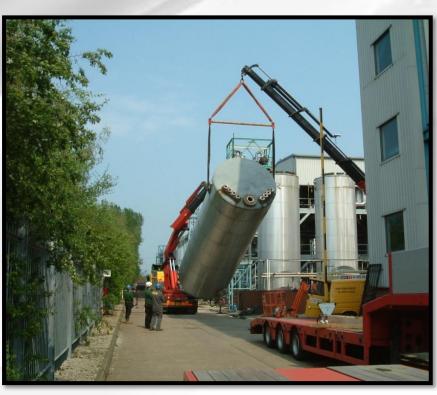
Right and below: Lifting out the first vessel. Again our investment in plant and equipment designed to our specifications gives us greater control throughout the project.

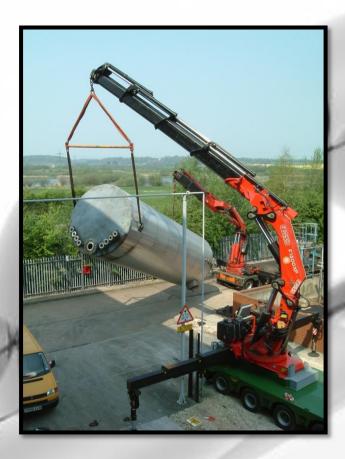
Left: Tandem lifting the vessel into a horizontal position to allow transport by road to the new site.

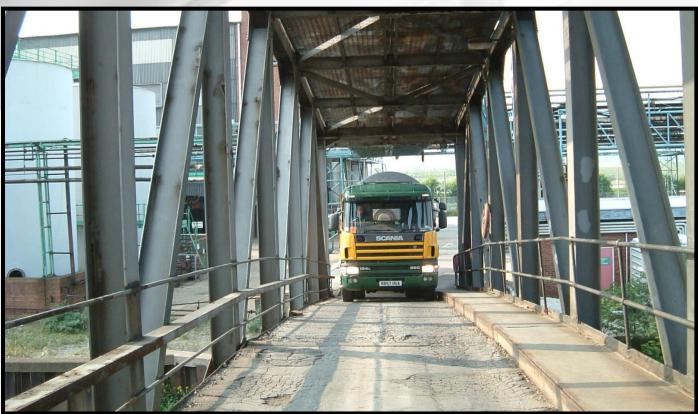
Below: The only access for articulated vehicles was over a narrow bridge with a 40t weight limit. This meant that although our Lorry mounted crane vehicles could carry the vessel it was too heavy to traverse the bridge safely and so we transferred the vessels onto a smaller, lighter vehicle to move the vessels to the on site storage area prior to transporting to Cardiff.

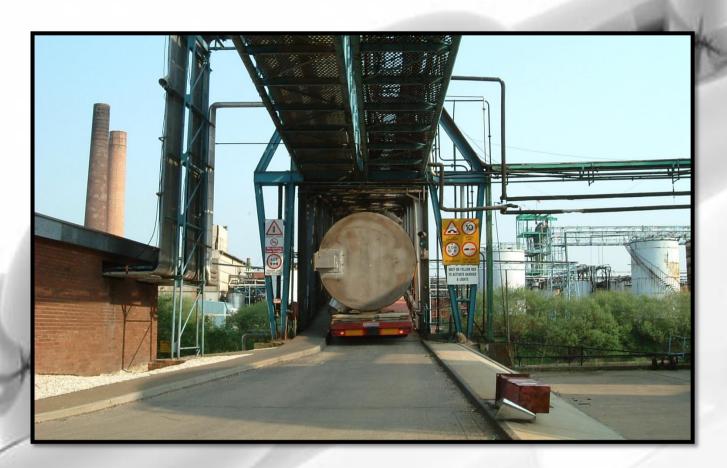
Above: Rear view of the vehicle transporting the vessel.

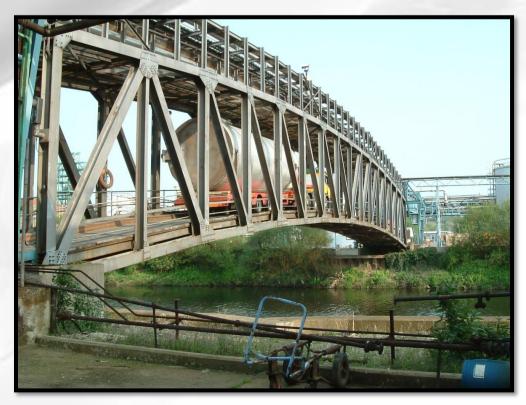
Below and Left – Our vehicle slowly crosses the bridge

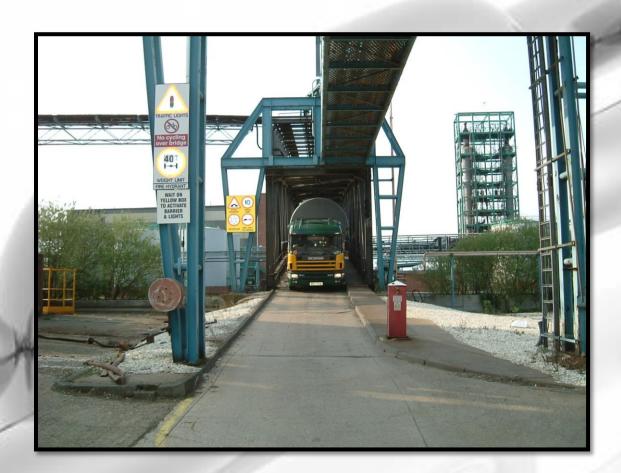
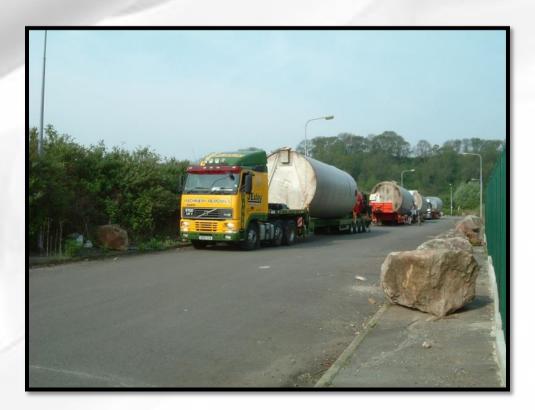
Left - Four of the vessels lined up on the Cardiff off site storage area. The rest of the vessels were transported to site once the crane was in position as there was not sufficient on site storage in Cardiff to allow all the vessels to be stored there at once.

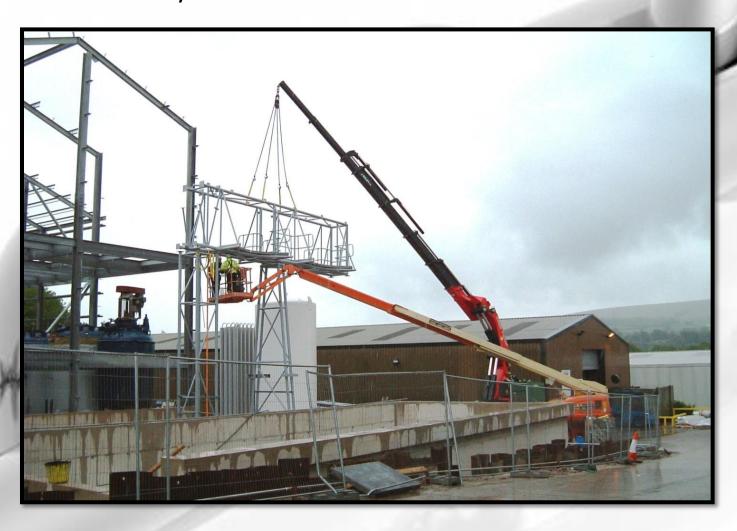
Above: Installing the newly engineered walkway onto the legs. The weather has decided to take a turn for the worse.....again!

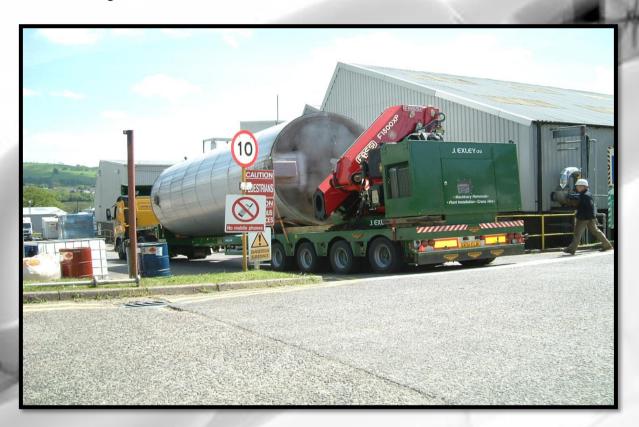
Below: This shows the gradient of the hill that the site is built on.

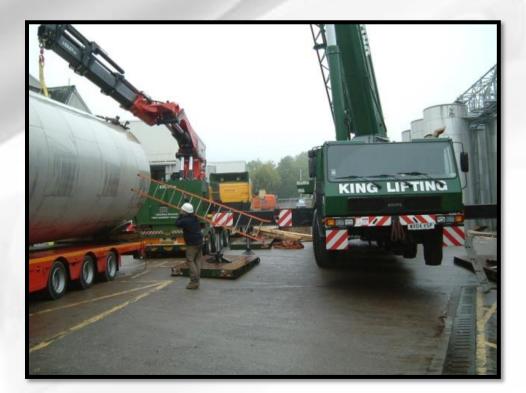
Left: Lifting the vessel upright again before final positioning. Again this shows the gradient of the site as the front of the crane was nearly 2m off the floor by the time it was level for lifting.

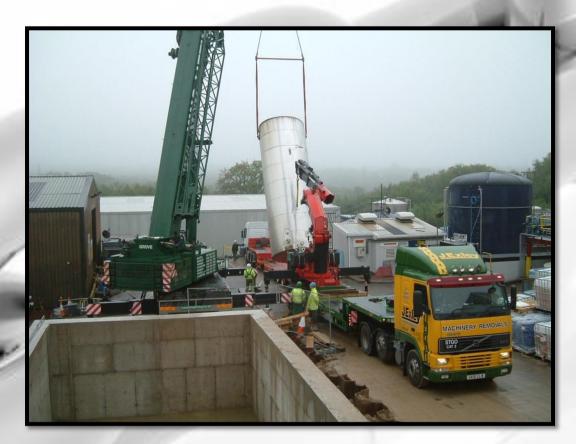
Right: Using our Hiab vehicle to tandem lift the vessel was preferential as we had limited space to set up two mobile cranes and position the delivery vehicles as we had scheduled delivery times to adhere to so we did not interrupt production.

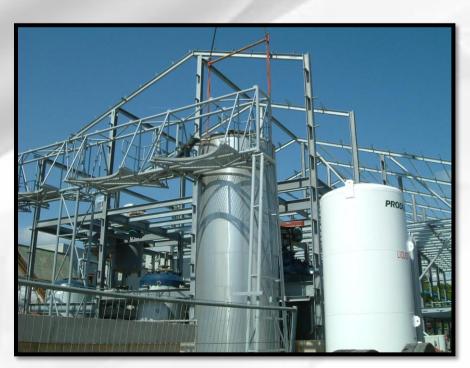
Above: Adding the finishing touches to the gantry after all the vessels have been positioned.

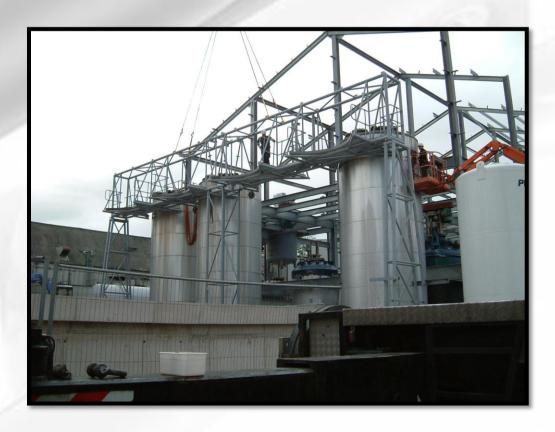
Left: One of slinger/banksman guiding a vessel into position so as not to damage the aluminium lagging.

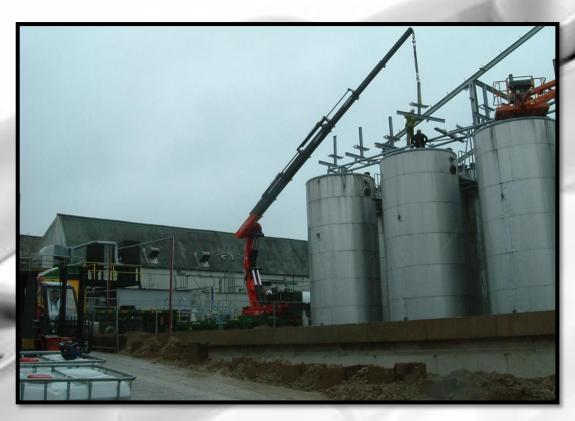
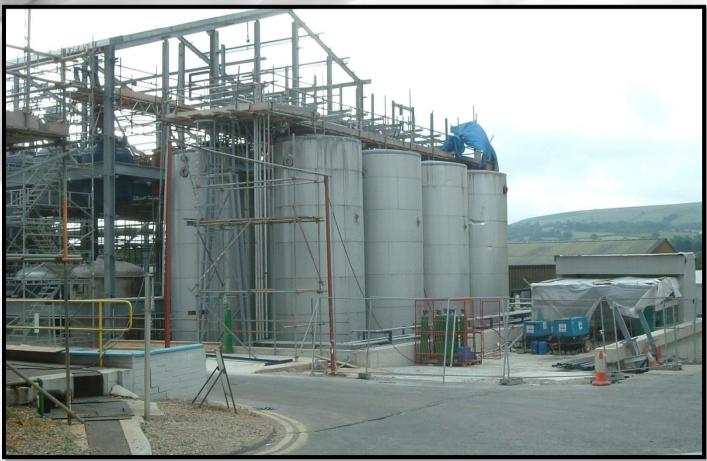
Above: The finished project
